SAARC Workshop on
LANDSLIDE
Risk Management in South Asia

11-12 May 2010, Thimpu, Bhutan

Organised by
SAARC Disaster Management Centre, New Delhi

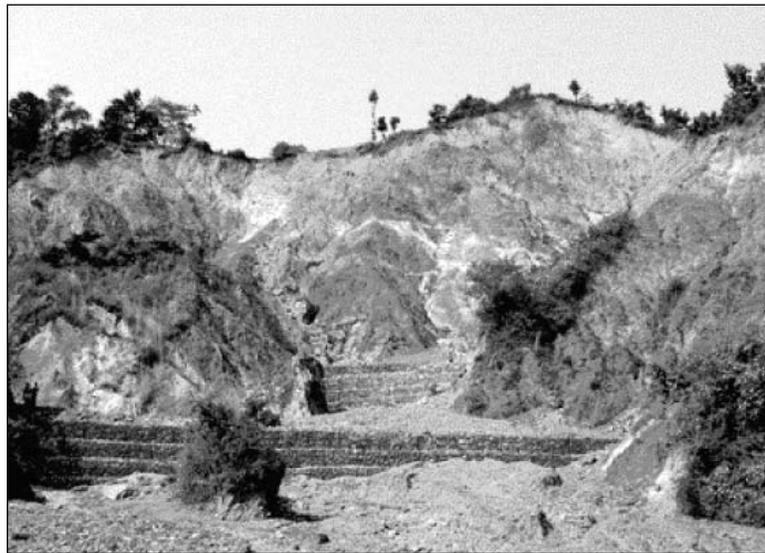
Figure 2: A frontal view of Kherbandi Landslide of Bhutan. It is a problem, more than two decades old located at km5 on the highway . (Photo Courtesy: Kishor Kumar)

The heavy monsoonal rain of the year 2000 destroyed a vast area including hill slopes, the national highway and the nearby police check post. It is precisely the landslides like this which demonstrate that piece-meal implementation of control measures such as toe walls, breast walls and check dams bring no more than momentary relief. Other SAARC countries will have numerous such examples to underscore the importance of a comprehensive approach to landslide control.

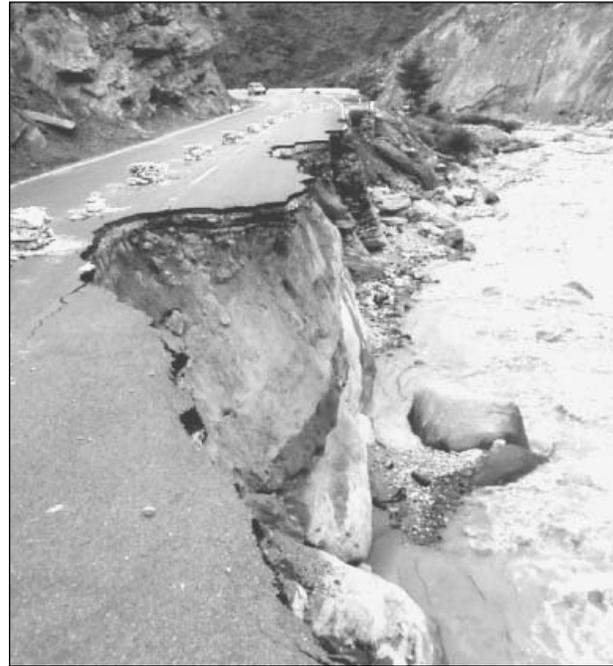
Figure 3: Breach of a stretch of highway that occurred on 26 May 2009 at Km 143.23. (Courtesy S.S. Porwal)

Breaches on the highway because of slope failures are also common. One such failure which occurred on the 26 May 2009 at km 143.23⁶ is shown in Figure 3. There are landslides that threaten culture monuments. For example, Gumpha (a Buddhist temple) is under threat from landslides.

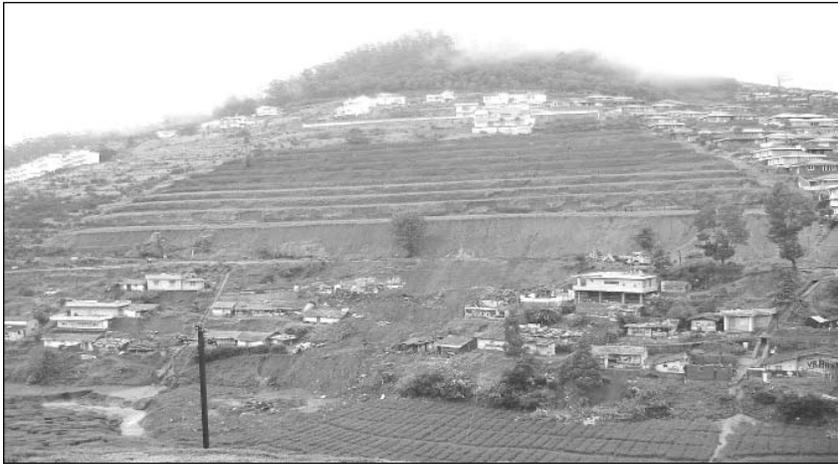
Figure 4: One the most spectacular and most recent landslide in the Nilgiris which destroyed human settlements at the foot of a slope. (Courtesy: Ganapathy)

majority of landslides do occur in a loose cover of debris consisting of boulders. The major landslides in the Nilgiri hills are the Runnymede landslide, the Glenmore slide, the Conoor slide and the Karadi-pallam slide. One the most spectacular and most recent landslide in the Nilgiris is shown in Figure 4. Varnunawat landslide (2003) which threatened human settlements at the foot of a slope is one of the better studied landslides in India, Figure 5.

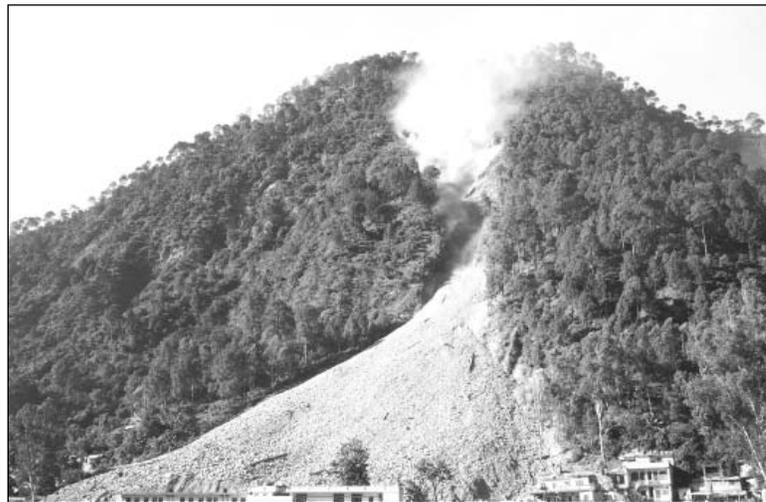
Figure 5: Varunawat landslide in the Uttarakhand State of India is yet another example of a major landslide which threatened human settlements at the foot of a slope. (Courtesy: Nawani)

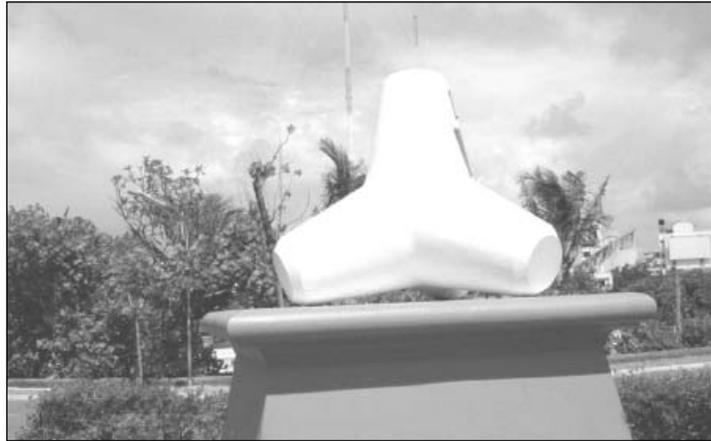
Figure 6: Tetrapod Technology is extensively in use in Maldives. The picture shows a Tetrapod on public display at Male. (Courtesy: R. K. Bhandari)

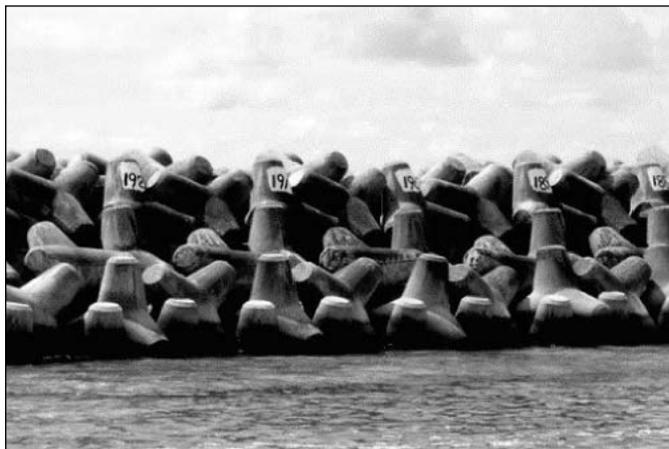
Figure 7: Tetrapod Technology is extensively in use in Maldives. The picture shows a Tetrapod wall protecting a coastal slope. (Courtesy: R. K. Bhandari)

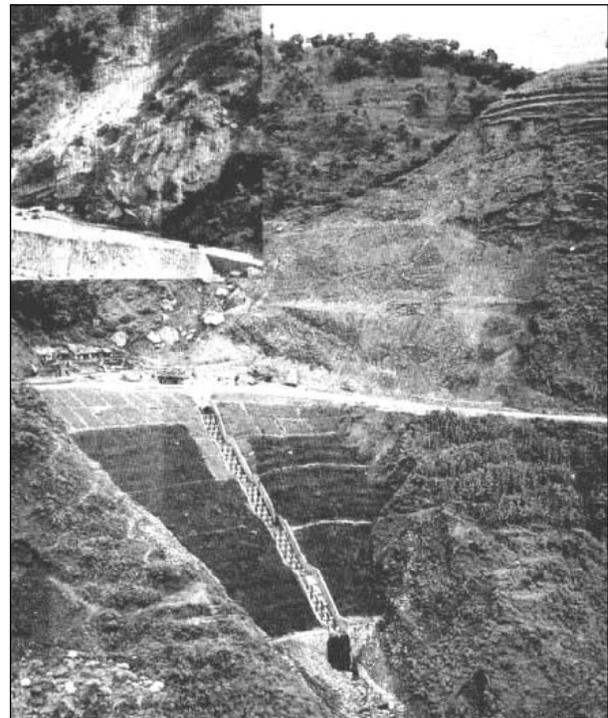
*Figure 9: Landslide Hazard Management on Kodari Highway in Nepal
(Courtesy: B. N. Upreti and M. R. Dhital)*

There are several examples of landslides destroying road infrastructure. The landslide of 10 September 1978 which struck at 12 noon destroyed a RCC bridge of East-West Highway even before it could be inaugurated. Landslide Hazard Management on Kodari Highway is shown in Figure 9. It carries inset of Jogimara landslide.

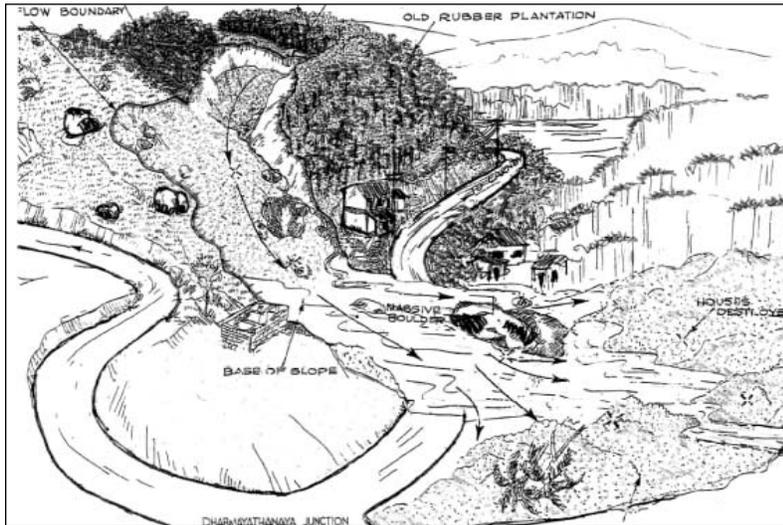
Figure 11: An artist's impression of the Helauda Earthslide in the Ratnapura district of Sri Lanka (Artist: Sunil Fernando under guidance of R. K. Bhandari).

Recall the major devastating events of 6-10 January 1986 which killed people in Mandaranuwara, damaged houses, paddy fields, roads and a bridge at Madulla, and a hospital in Mulhalkele. Three years later, on 3 June 1989, landslides killed 14 persons in Mamaduwa, 24 persons in Neluwattukanda of the Kegalle District and 8 persons at Paraiyagala in the Nuwara Eliya District. Four years there after, on 8 October 1993, an earth flow at Helauda on the Ratnapura-Wewelwatta road killed 31 people at the foot of a slope, Figure 11. In the year 2003, another 8 landslides occurred, killing 114 people.

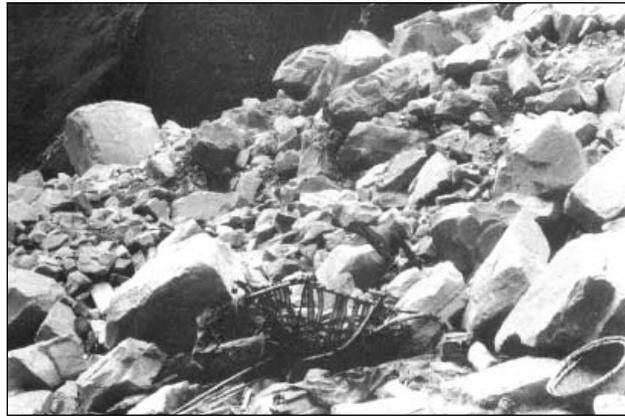
Figure 12: The Rock Avalanche which killed about 220 people in the State of Uttarakhand in India buried the village of Malpa under heaps of debris at the foot of the slope. High vulnerability of human settlements at the foot of a problematic slope represents a typical situation that call for proactive mitigation measures. (Courtesy : Kishor Kumar)

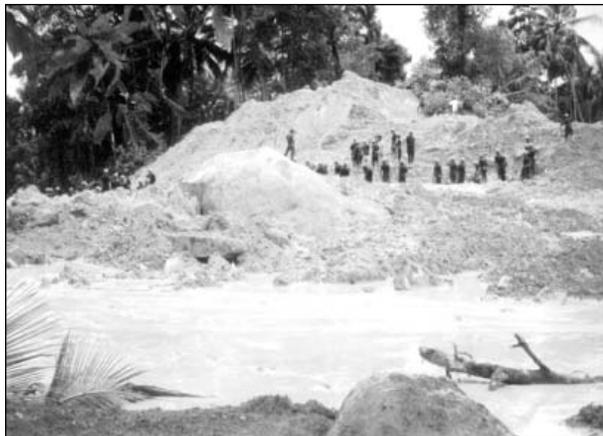
Figure 13: A landslide catastrophe similar to the Malpa Rock Avalanche tragedy in India (Figure 19 above) occurred at Helauda in the Ratnapura district of Sri Lanka. (Courtesy: R. K. Bhandari)

pal and there were spate of landslides on both sides of the territorial divide suggesting that a joint initiative would be the best way of managing such landslide risks in future. Then other countries of the region can also add value to such studies by bringing in their own pool of experience. For instance, Sri Lanka had gone through a similar experience that India had at Malpa. More than 200 pilgrims got buried under the Malpa rock avalanche at the foot of the slope, Figure 12. In Sri Lanka, when the Helauda Earthslide struck, 31 people got buried alive at the foot of a slope, Figure 13.

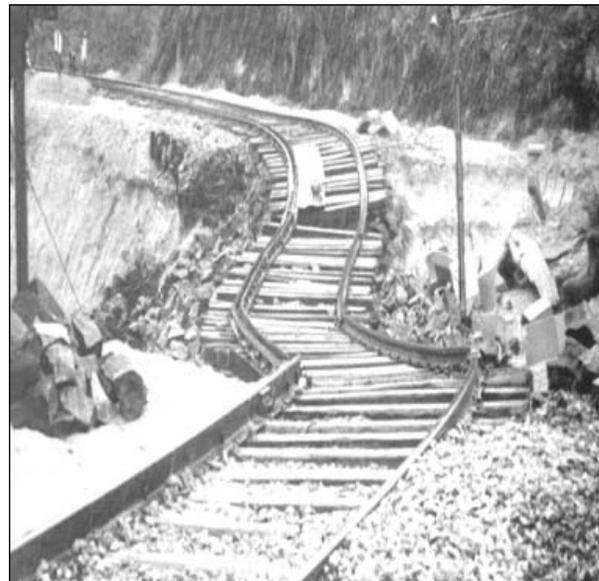
Figure 14: The more than 100 year old Watawala Earthslide in Sri Lanka was completely controlled through use of innovative subsurface drainage technology. Despite this, no other SAARC country has used this technology to control similar landslides. (Courtesy: R. K. Bhandari)

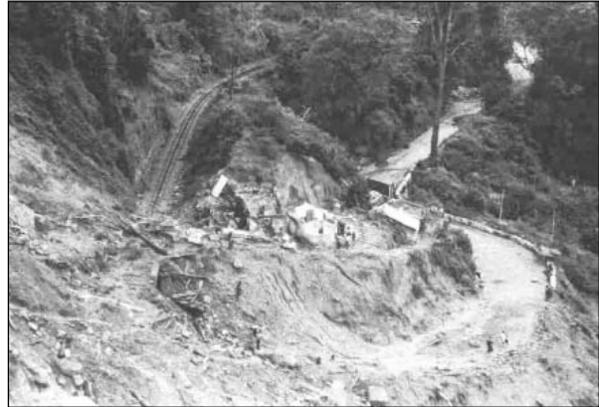
Figure 15: A landslide that destroyed a railway line in India.
(Source: GSI Report)

has several similar landslide spots and one such is shown in Figure 15.

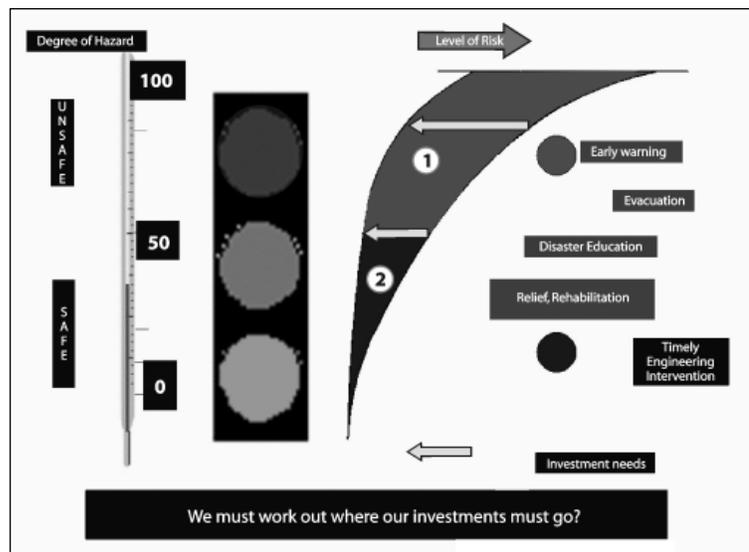
Figure 19: Engineering interventions are affordable and effective when landslide problems are small and new (blue zone). Investments on preparedness for evacuation and quick response become inescapable when hazard and risk levels are high (red zone). (Courtesy: R. K. Bhandari)

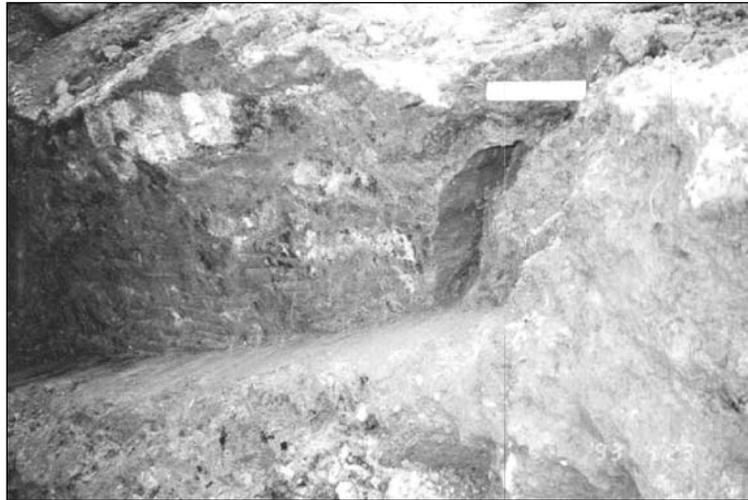
Figure 20: Visual evidence of discrete boundary shear at the Watawala Earthslide in Sri Lanka. (Courtesy: R. K. Bhandari)

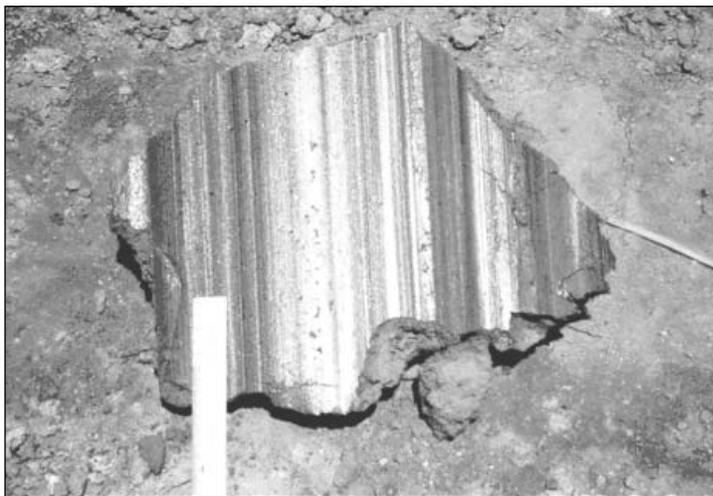
Figure 21: An excellent example of the striated and highly polished and slicken-sided slip surface observed in the undisturbed sample from the basal slip surface of the Watawala Earthslide in Sri Lanka. (Courtesy: R. K. Bhandari)

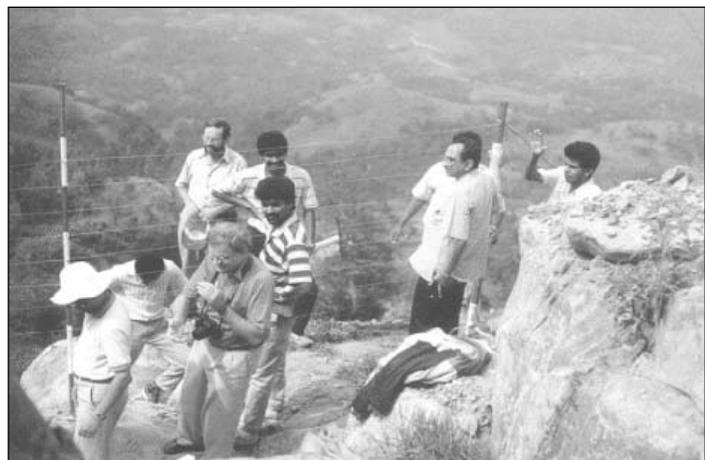
Figure 22: An early example of a simple wire-actuated early warning system installed at the Viharagalla landslide in Sri Lanka. (Source : NBRO, Sri Lanka)

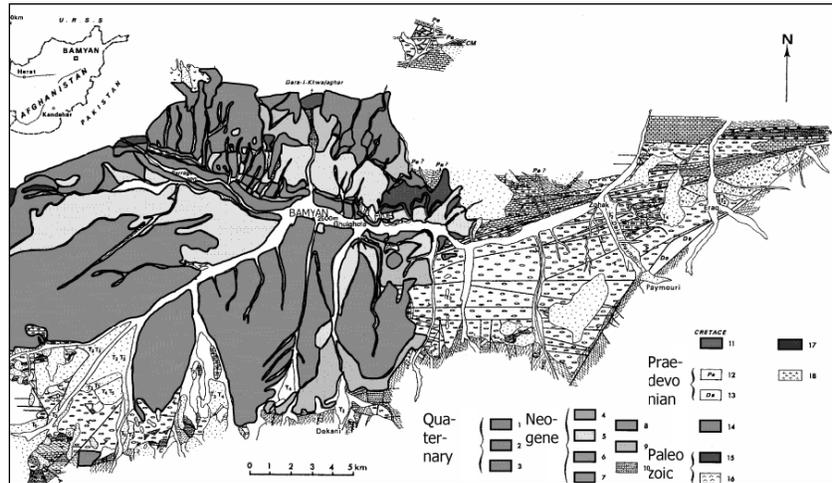
Figure 1: Geological map of Bamiyan (Lang, 1971; redrawn from Reineke, 2006)

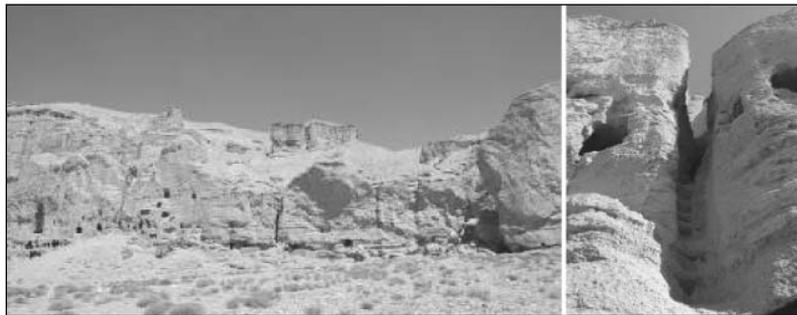
Figure 2 : Debris accumulation (left) and gully erosion on the slope face of the Bamiyan cliff

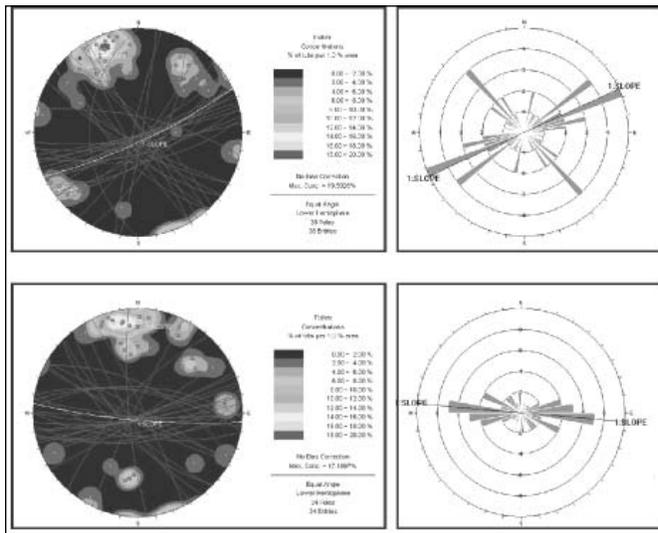
Figure 3 and 4 : Joints orientation sets of the W part of Bamiyan cliff (stations 1-10, above) and of the E part of Bamiyan cliff (stations 11-17, below) represented through stereonet (left) and rose diagram (right)

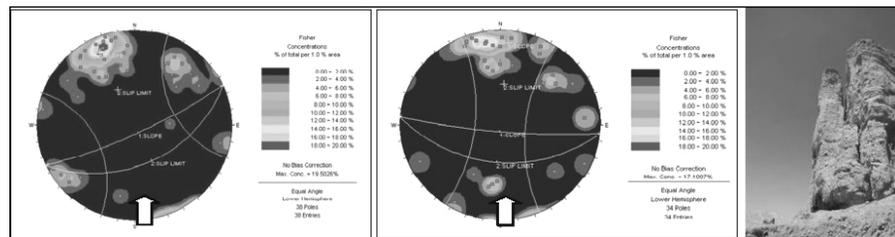
Figure 5 : Results of kinematic analysis for toppling for W side (left) and E side of the cliff (middle); the arrows show the region where toppling is possible (between slip limit and lower stereonet border). Toppling evolution in the cliff (right)

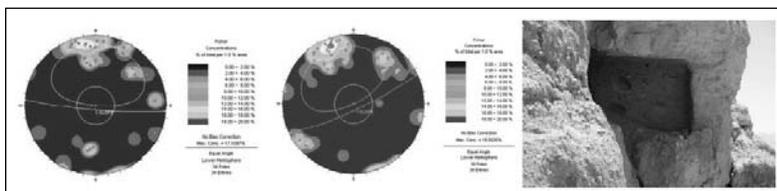
Figure 6 : Results of kinematic analysis for planar sliding for W side (left) and E side of the cliff (middle); the arrows show the region where planar sliding is possible (inside the slip limit area and the upper friction cone line). Planar rock-slide involving an ancient cavity (right)

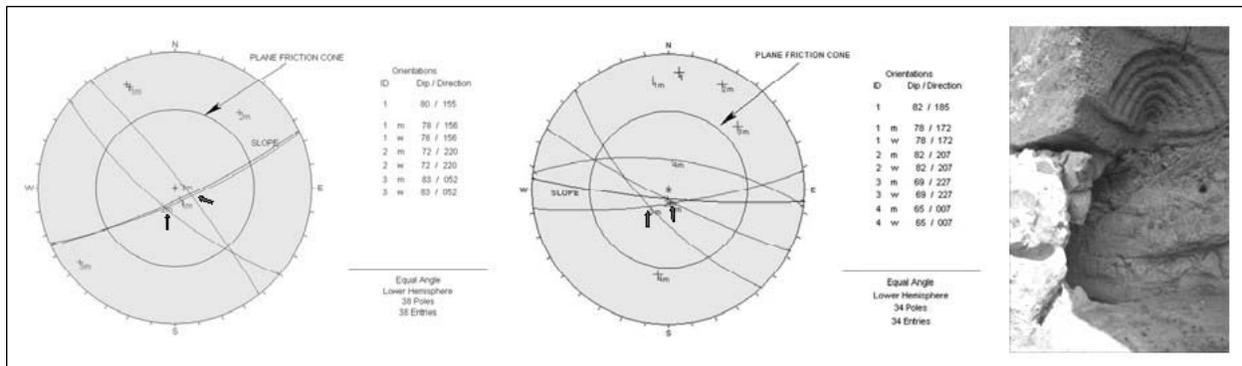
Figure 7: Results of kinematic analysis for wedge failure for W side (left) and E side of the cliff (middle); the arrows show the intersections of planes that may cause sliding inside the potential area (crescent shaped region between slope limit and lower friction cone). Potential wedge sliding along the cliff (right).

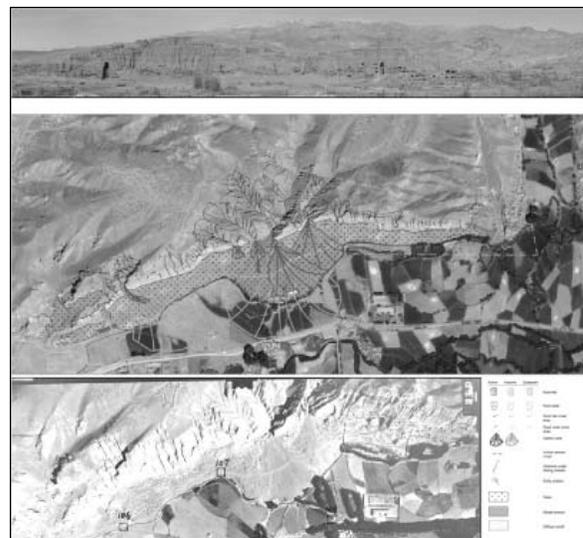
Figure 8: View of the Bamiyan valley (upper) and geomorphological map of the cliff where the giant statues of Buddha are located. The distance between the niches is 790m. The lower aerial photo is the first image of the Bamiyan valley (late '60)

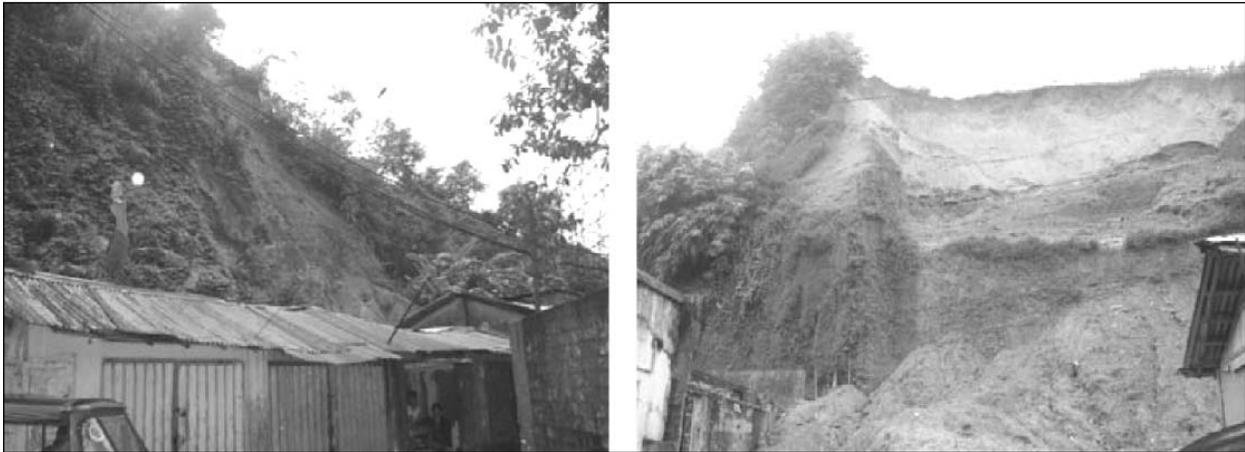
Figure 4: Showing the landslide happened due to hill cutting for construction purpose

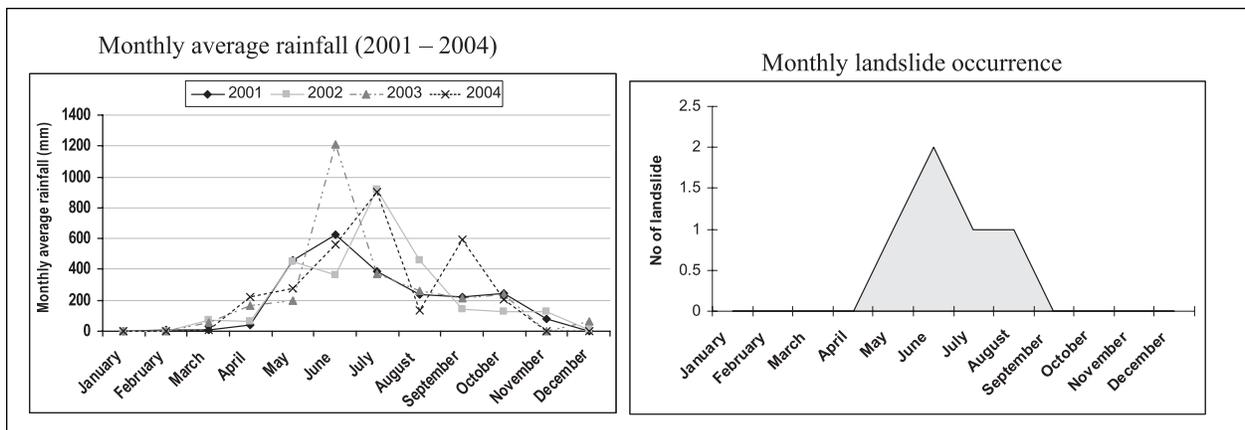
Figure 5: Relationship between rainfall and landslide occurrence in Bangladesh hills (Source: BBS, 2007)

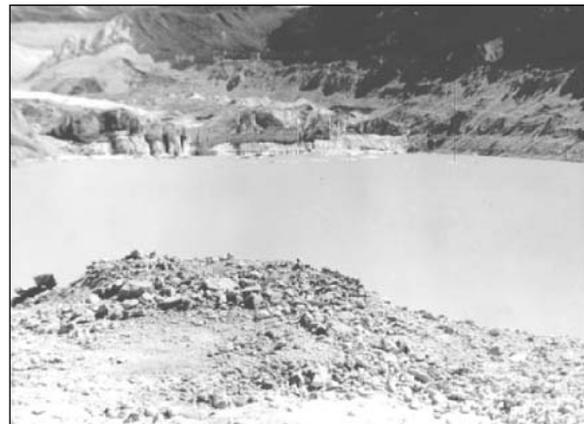
Figure 2: Luggye glacial lake.

Change in climate is resulting in melting of these glaciers. Consequently, the volume of the glacial lakes increases, thereby increasing the hydrostatic pressure on barrier dams (created by glacial debris), which give way causing catastrophic outburst. For instance, in 1994, Luggye glacial lake (Figure 2) outburst in Lunana flooded and damaged rice fields, bridges, houses and the dzongs (Figure 3), demonstrating Bhutan's vulnerability to such extreme events. GLOF and flash floods had also occurred in the same region earlier in 1950, 1960 and 1968.

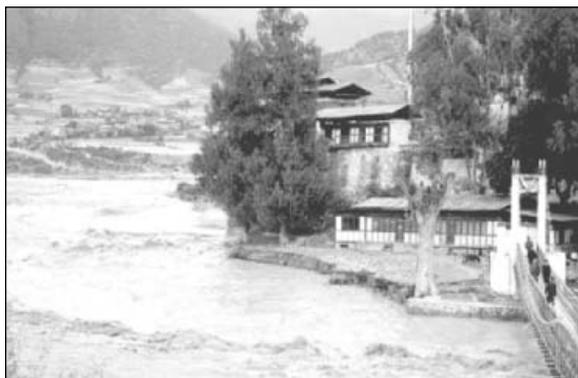
Figure 3: Punakha Dzong (partly destroyed by GLOF).

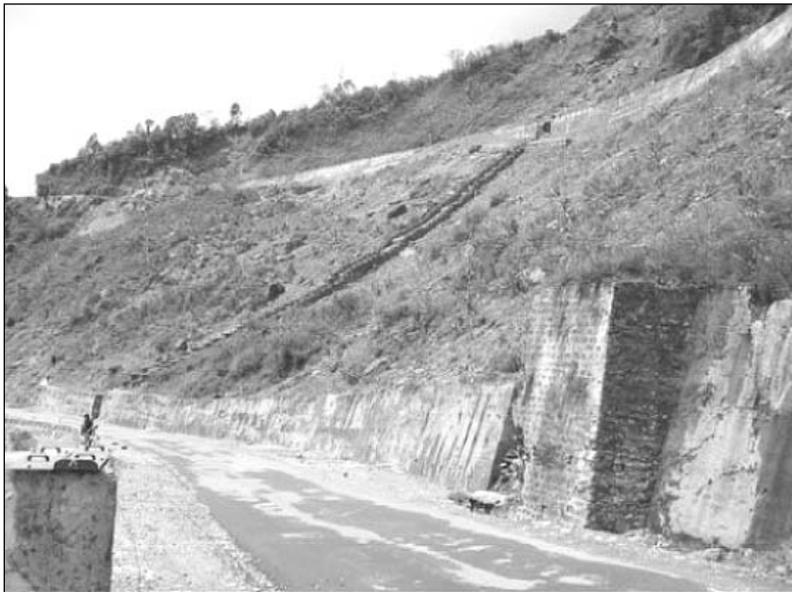
Figure 4: Sorchen landslide.

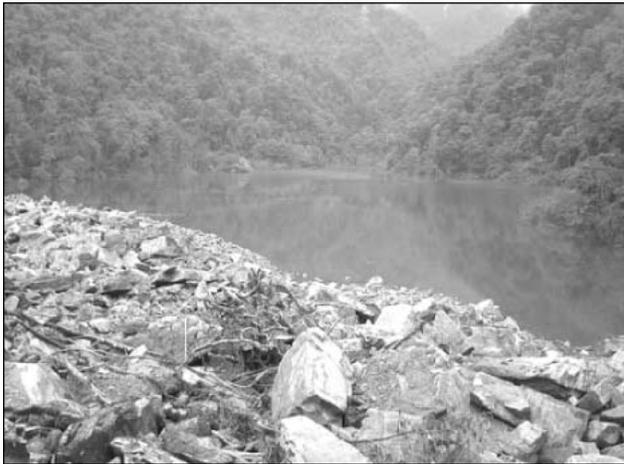
Figure 5: Tsatichu landslide dam.

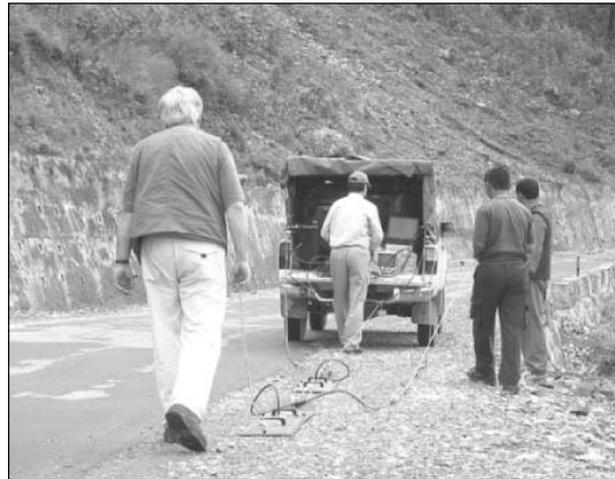
Figure 6: Geophysical survey (GPR).

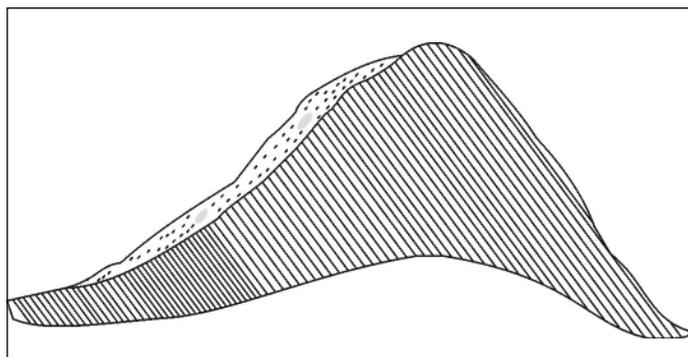
Figure 1: Formation of Earthquake-induced Landslides (after Oldham, 1899).

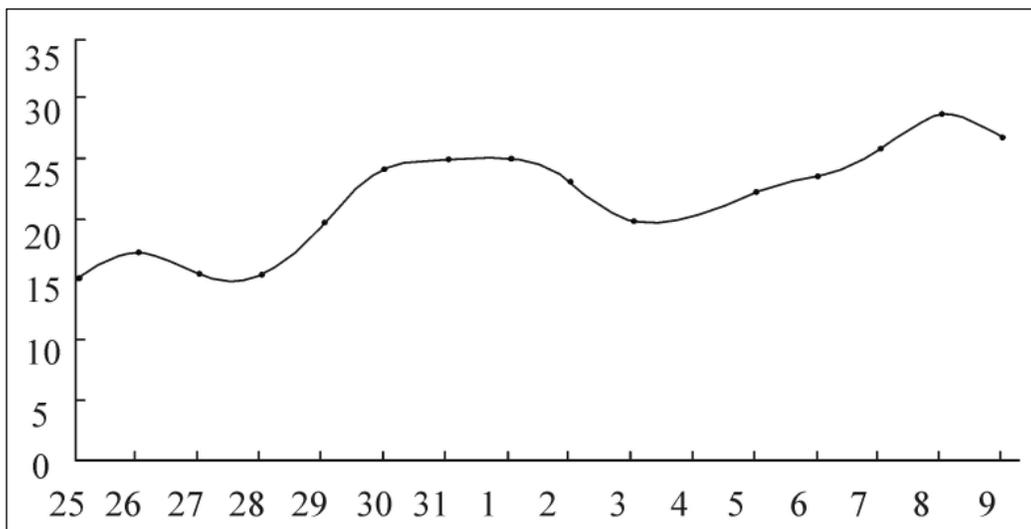
Figure 3: Daily discharge of Mandakini River recorded at Chandrapuri showing the impact of earthquake on the hydrological regime of the area (after Shah and Bartarya, 2002).

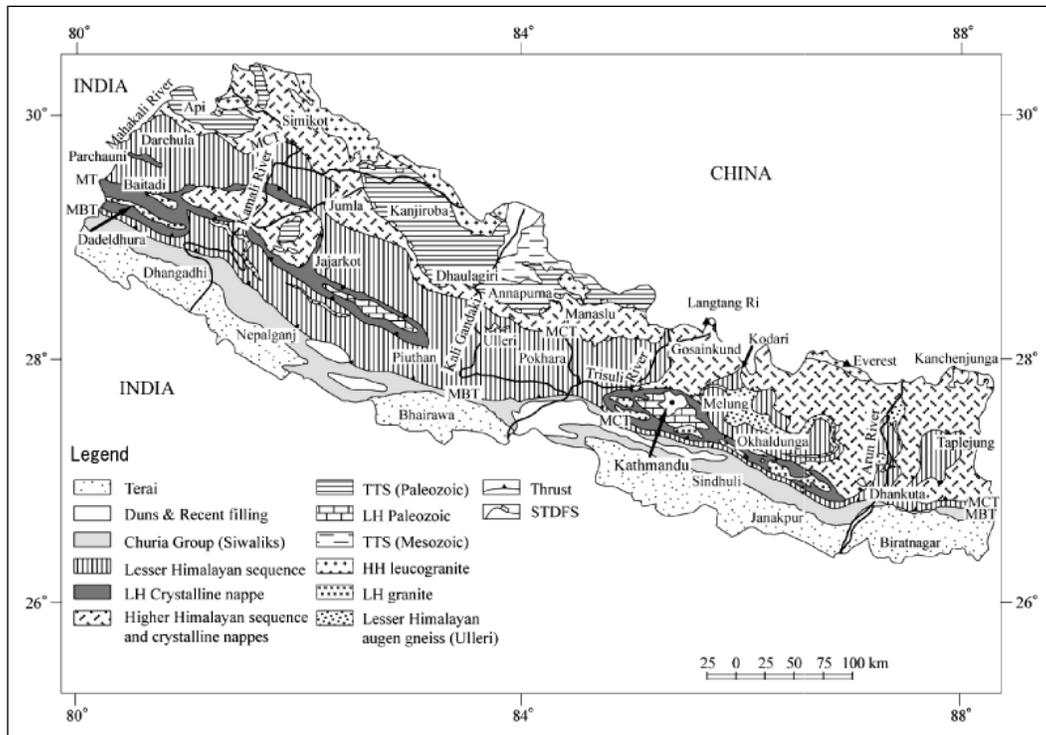
Figure 2: Geological map of Nepal (modified after Upreti and Le Fort, 1999). LH, Lesser Himalaya; HH, Higher Himalaya; TTS, Tibetan-Tethys sequence; MBT, Main Boundary Thrust; MCT, Main Central Thrust; MFT, Main Frontal Thrust; STDS, South Tibetan Detachment System.

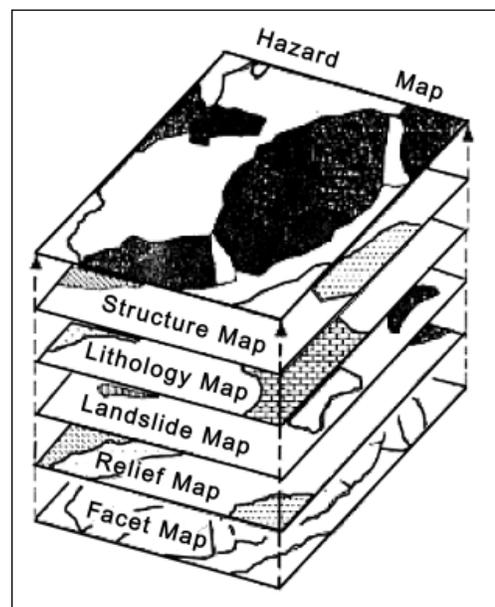
Figure 7: Conceptual idea of superimposition method of landslide hazard mapping.

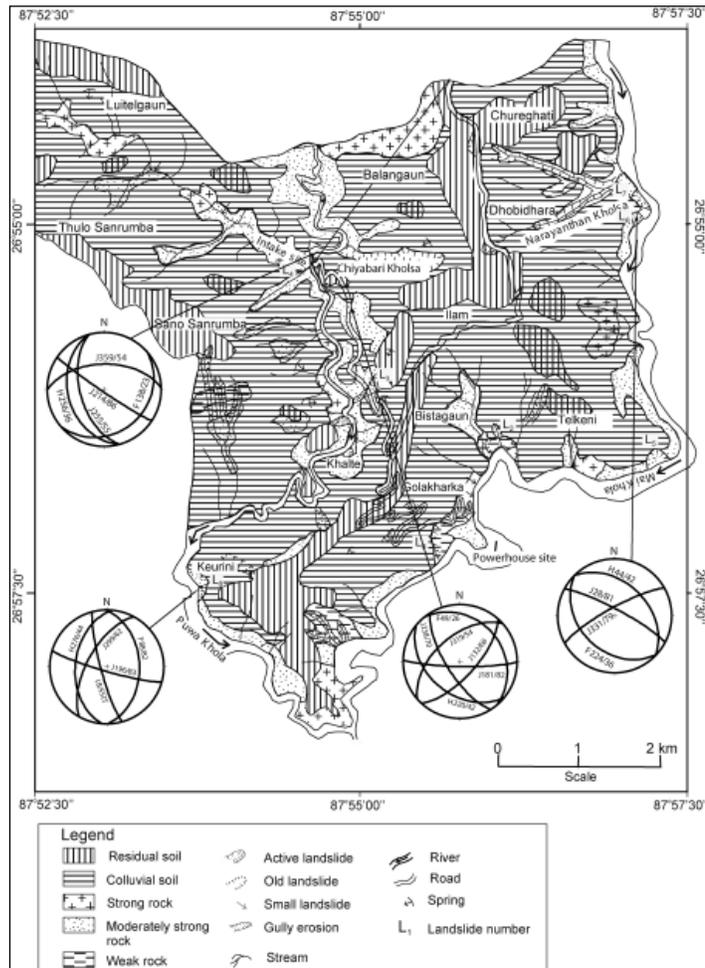
Figure 10: Engineering geological map of Ilam area.

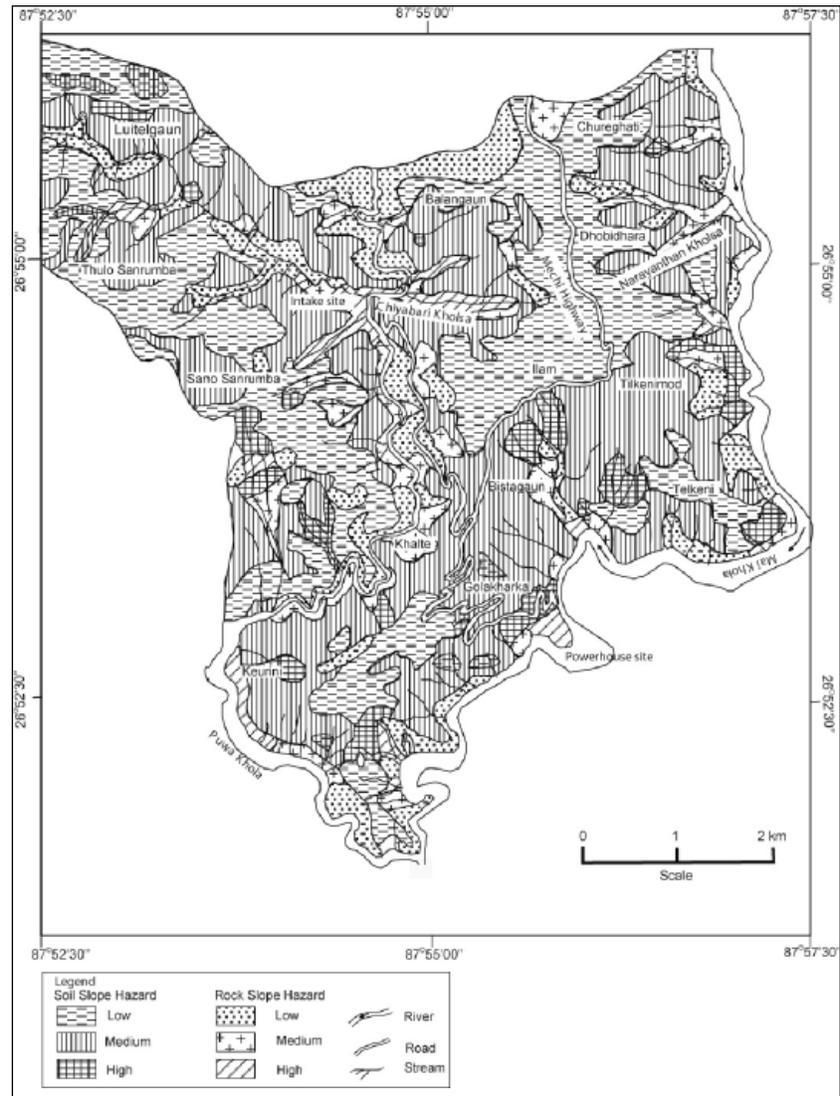
Figure 12 : Relative landslide hazard map of Ilam area.

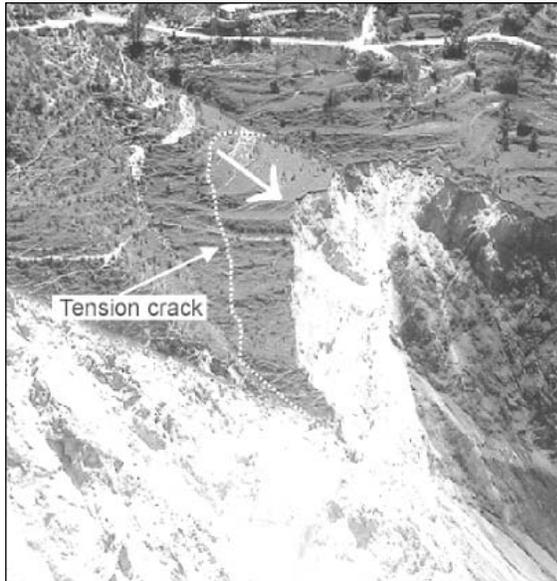
Figure 1: A cracked slope in unweathered Precambrian dolomite at Mukree. Here a block about 50 m in length is sliding forward. At the time of the photograph the tension crack was about 50 cm in width.

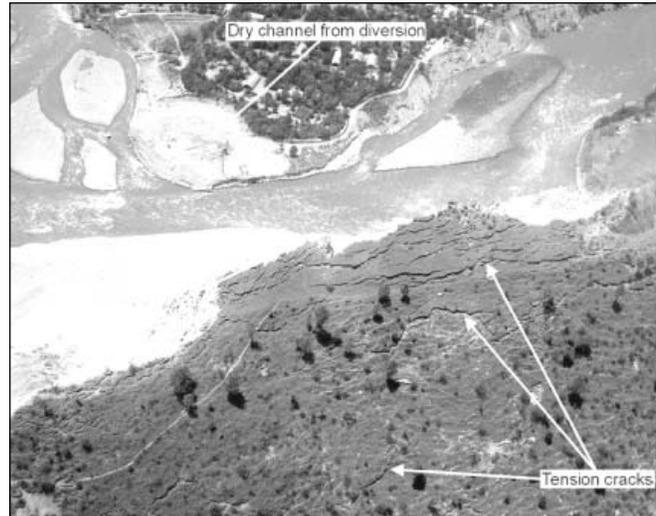
Figure 2: A cracked slope in unweathered Precambrian dolomite above the Nisar camp upstream on the Neelum river from Muza arabad. The cracks daylight on a reverse slope at the top of a 200 m cliff. A large failure here during the earthquake blocked the river, causing the labeled change in the drainage.

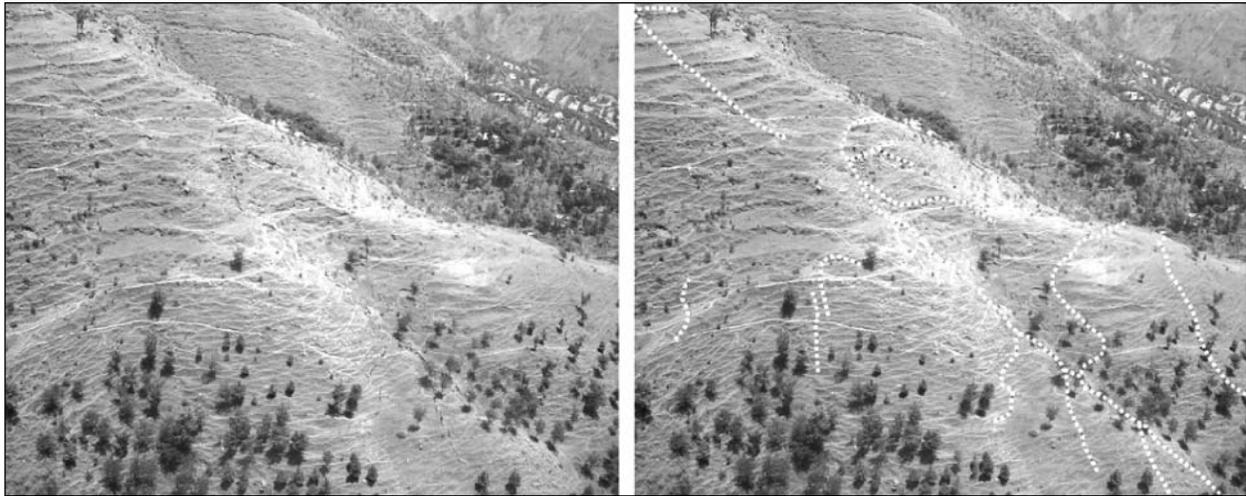
Figure 3: A cracked slope in colluvium in the Jhelum River valley. The annotated image shows the locations of the main cracks. Note the clearly defined main block, complete with fully developed lateral shears, and less well developed slope failures above and on the margins of the main slide. Crack widths at this location exceed 1 m.

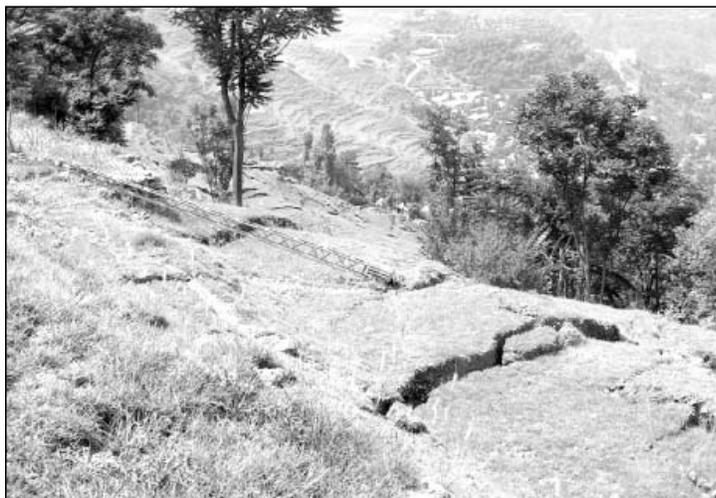
Figure 4: Ground cracks at Botha, on the colluvium slopes above Muza arabad. At this location there are multiple arrays of cracks extending upslope for over 200 m, and across the slope for over 500 m. The orientation of the cracks varies according to local topographic controls.

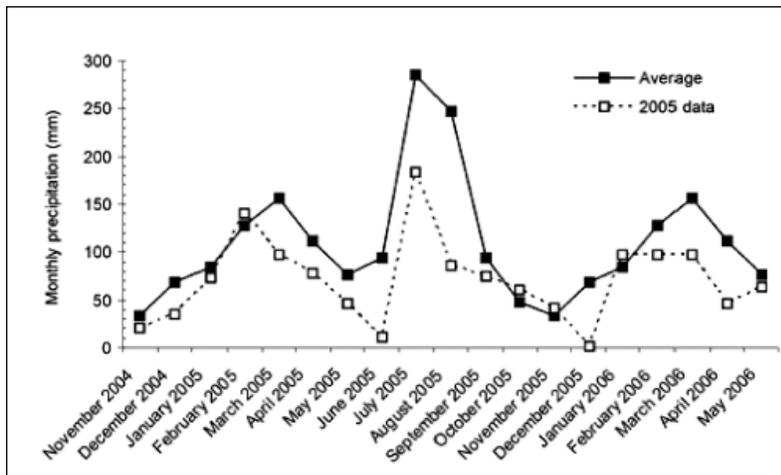
Figure 5: Rainfall record for the grid square 73-74° E 34-35° N (data from GPCC — see Rudolf et al. 2005) for the period November 2004 to May 2006. It is clear that for most of the year before the earthquake in October 2005 the rainfall level was significantly below average. In particular there was a very low level of monsoon rainfall. Interestingly, the period since the earthquake is also marked by low level of precipitation.

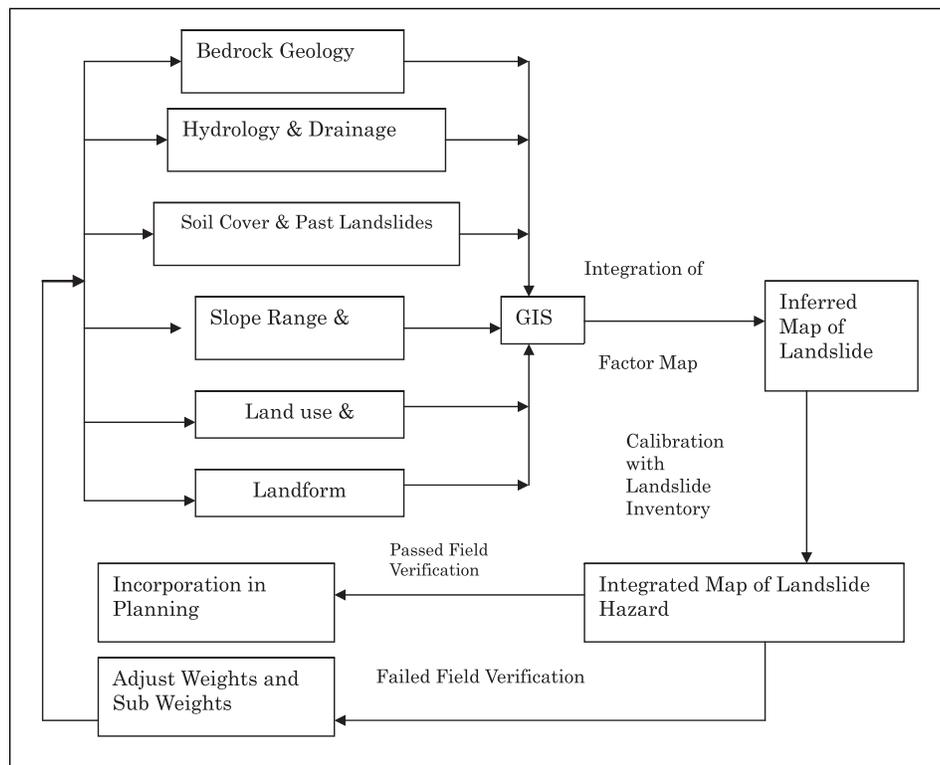
Flow Chart No. 1 : Landslide Hazard Mapping Methodology

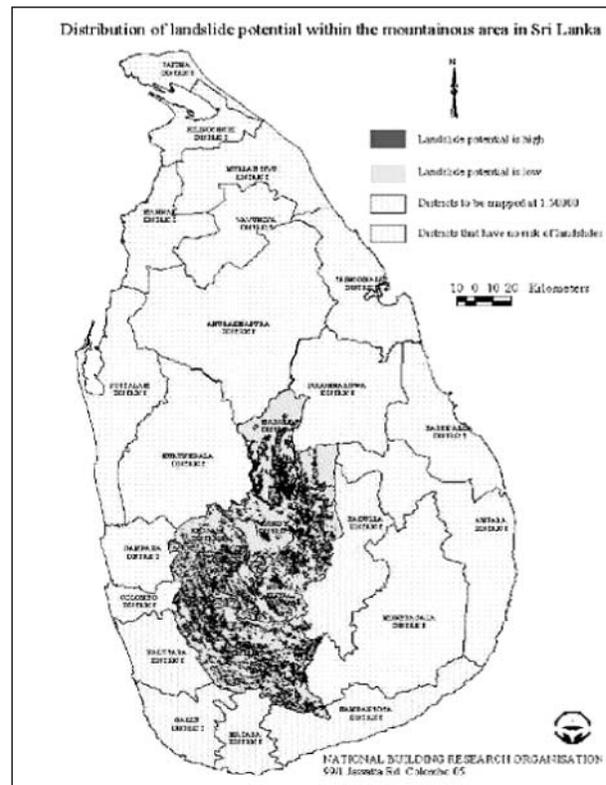
Figure 2: Partially Completed landslide zonation map for Sri Lanka.

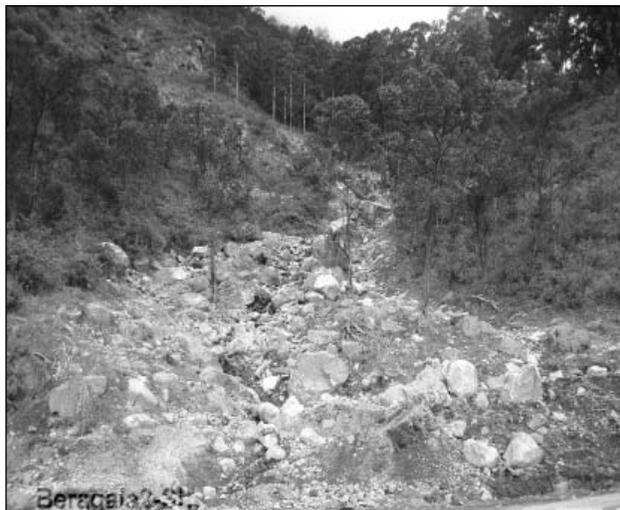
Landslide at Beragala - 2008.

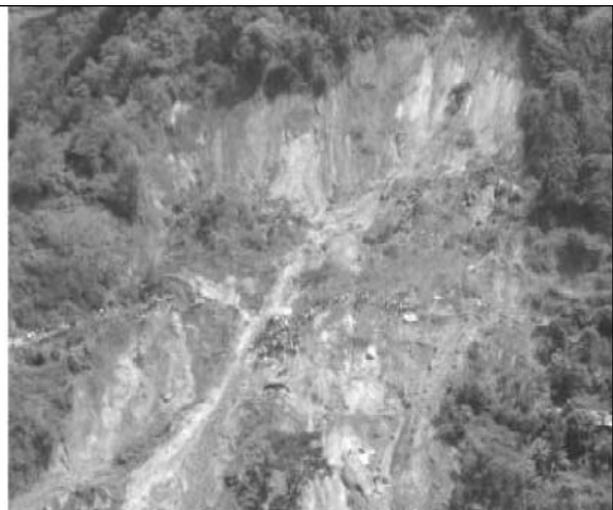
Landslide at Munwatta, Walapane - 2007.
